**Flood Control Project Maintenance  
Levee Inspections****LMA District Cover Sheet****Spring 2016 Levee Inspection Results****Sacramento Maintenance Yard Sacramento Bypass**

**Levee Inspection Report By Mile - Spring 2016**

**Sacramento Maintenance Yard Sacramento Bypass**

Waterway	Bank	Unit Miles	Inspection Start/End	Inspector
Unit No. 01 Sacramento Bypass or North Levee	Right	1.74	03/02/2016 03/02/2016	Jai Lor

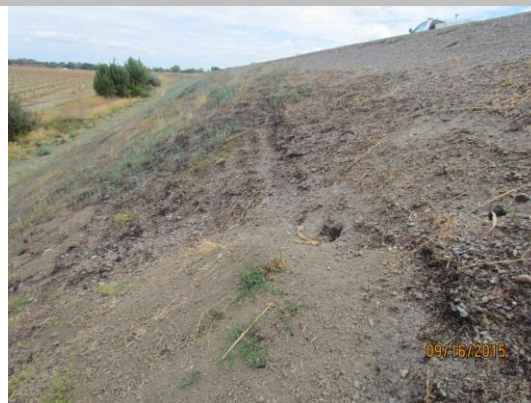
Photo 1 of 1 : SP\_2016\_ST0008\_284\_10\_20160302\_00003.jpg

LM Start	0.94	Rating **	M	Issue No.	10
LM End	0.94	Issue Type +	Ma	Location *	LS
Category	Earthen Levee			GPS Latitude/Longitude	
				Start	End
Item	Animal Control			38.602763 °	38.602763 °
				-121.576288 °	-121.576288 °
DWR ID	DWR_ST0008_01_f_2015_10				
Comment Code					
A3 : No rodents visible, but rodent burrows visible; need to backfill and compact or grout burrows.					
Inspector Comment

View of the rodent holes on the landward side of the levee looking upstream. Fall 2015.

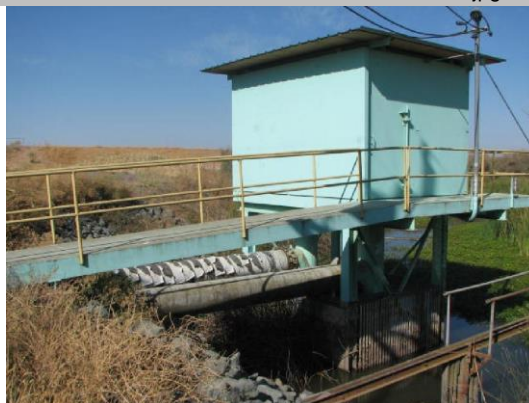
Photo 1 of 2 : UCIP\_SP\_2016\_44783\_20611.jpg

LM Start	1.10	Rating **	M	Issue No.	12
LM End	1.10	Issue Type +	En	Location *	LS
Category	Supplemental			GPS Latitude/Longitude	
				Start	End
Item	DWR UCIP Field Study			38.602180 °	38.602180 °
				-121.579130 °	-121.579130 °
DWR ID					
Comment Code					
Inspector Comment					
FS_ID:44783 DS_ID:19066 EP_NO: 13616 Repair Type: Non-Urgent Crossing Status: Found UCIP Comments: After more investigation depressions are from water run off. erosion repair needed FIELD_STRUCT_DESC: 1 of 2. A agricultural drainage pumping system with 24-inch and 20-inch steel discharge pipelines through the north levee of the Sacramento Bypass. The pipe is 6.33 ft below the crown and a siphon breaker on the WS. Vertical GI pipe trash rack on inlet structure. Application no. 13616, 1995 (revised). FS Date: 4/28/2015 2:43:01 PM

Landside view: pumping plant overview

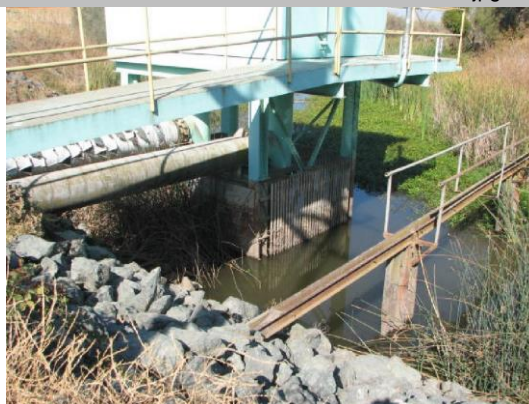
Photo 2 of 2 : UCIP\_SP\_2016\_44783\_20609.jpg

Landside view: vertical GI pipes in inlet structure.

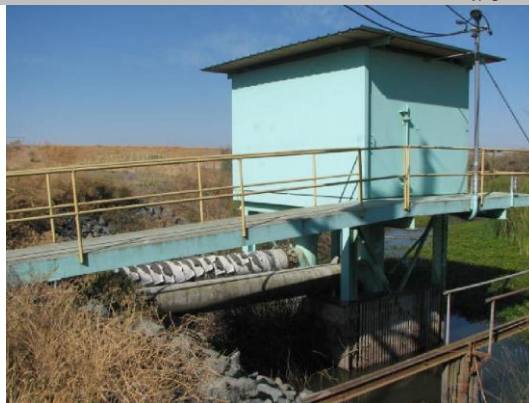
Photo 1 of 2 : UCIP\_SP\_2016\_44784\_20619.jpg

LM Start	1.10	Rating **	M	Issue No.	13
LM End	1.10	Issue Type +	En	Location *	LS
Category	Supplemental			GPS Latitude/Longitude	
				Start	End
Item	DWR UCIP Field Study			38.602128 °	38.602128 °
				-121.579150 °	-121.579150 °
DWR ID					
Comment Code					
Inspector Comment					
FS_ID:44784 DS_ID:19079 EP_NO: 13616 Repair Type: Non-Urgent Crossing Status: Found UCIP Comments: Horizontal Air vent on waterside slope. Green vegetation and depressions also found on waterside slope. FIELD_STRUCT_DESC: 2 of 2. A agricultural drainage pumping system with 24-inch and 20-inch steel discharge pipelines through the north levee of the Sacramento Bypass. The pipe is 6.33 ft below the crown and a siphon breaker on the WS. Vertical GI pipe trash rack on inlet structure. Application no. 13616, 1995 (revised). FS Date: 4/28/2015 2:43:26 PM

Landside view: overview of pumping plant

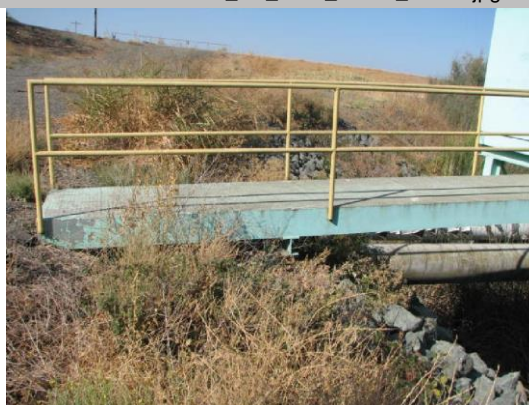
Photo 2 of 2 : UCIP\_SP\_2016\_44784\_20618.jpg

Landside view: walkway to the pumping plant
